Manhole Inspection Summary

Manhole # S25G__041MH

Insp Date: **8/30/07 7:09 AM**

Location Address: **1 CAREY ST**

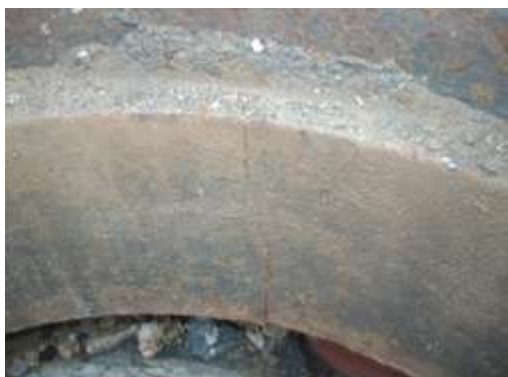
Defect 4

Offset: **3** (in.)

Condition: ☐ Sound ☒ **Cracked** ☐ Leaks

CRACKED FRAME

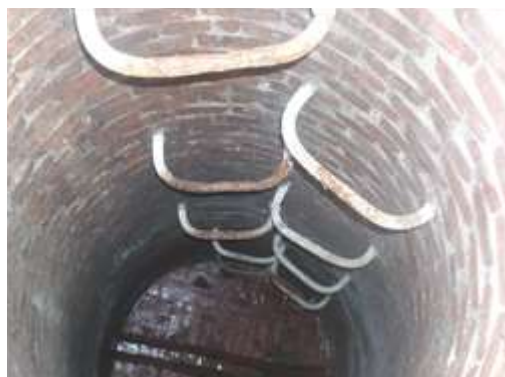
Defect 3

Count: **10** Missing: **0** ☒ **Corroded**

CORRODED STEPS

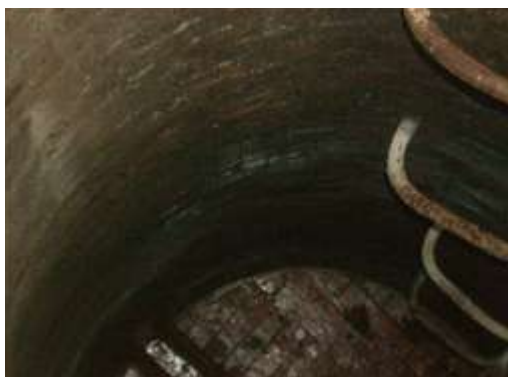
Defect 2

Infiltration: ☐ None ☐ Joint ☐ Cracks ☐ Mortar ☐ Roots ☒ **Wall**

INFILTRATION OF THE BARREL WALL

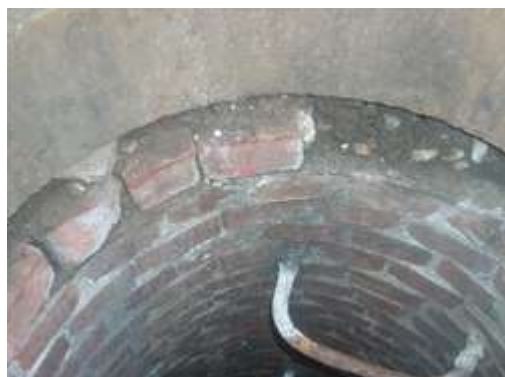
Defect 1

☒ Exists Material: **Brick**

Condition: ☐ Sound ☐ Cracked ☐ Root Intrusion ☐ Loose Brick ☒ **Deteriorated**

DETERIORATED CHIMNEY

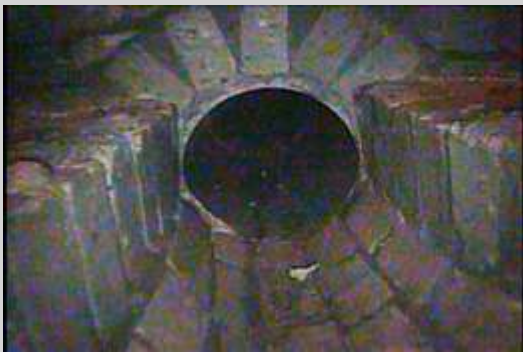
12 O'Clock Outflow

8 in. Circular Gravity Sewer
Pipe Out @ 12 O'Clock

Pipe Height: **8.4** (in.) Rod and Bar (Angled)
Pipe Material: **Clay** ☐ Pipe Lined
Invert Depth: **15.21** (ft.) Flow Characteristics: **None**
Deposits: ☒ None ☐ Mud ☐ Sludge ☐ Debris ☐ Grease
Silt Depth: (in.) Deposits Extent:
Infiltration: **None** Pipe Seal Cond: **Sound**

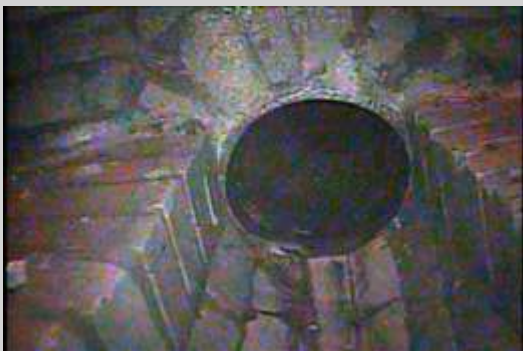
4 O'Clock Inflow

8 in. Circular Gravity Sewer
Pipe In @ 4 O'Clock

Pipe Height: **8.4** (in.) Rod and Bar (Angled)
Pipe Material: **Clay** ☐ Pipe Lined
Invert Depth: **14.99** (ft.) Flow Characteristics: **None**
Deposits: ☒ None ☐ Mud ☐ Sludge ☐ Debris ☐ Grease
Silt Depth: (in.) Deposits Extent:
Infiltration: **None** Pipe Seal Cond: **Sound**

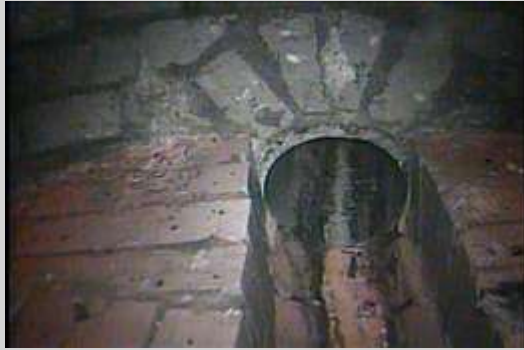
7 O'Clock Inflow

6 in. Circular Gravity Sewer
Pipe In @ 7 O'Clock

Pipe Material: **Clay** ☐ Pipe Lined

Invert Depth: **14.46** (ft.) Flow Characteristics: **None**

Infiltration: **None**

Pipe Seal Cond: **Sound**
